# **WALKER MARINE SERVICES**

# **Report of Marine Survey**

**Cruisers Yacht 3372**

October 24, 2014

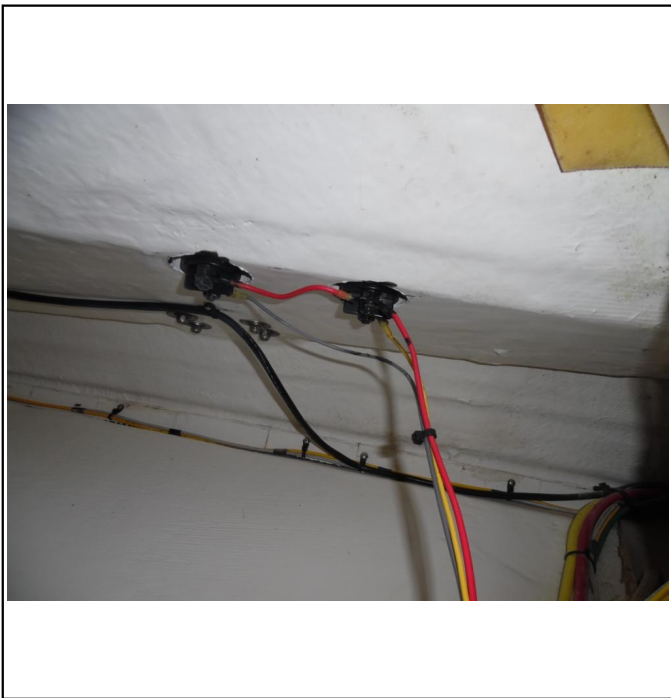
Automatic two-way Maxwell Windlass with two stations, foot pedals at bow and controls at helm station. Operational and appears serviceable.	
FINDINGS	RECOMMENDATIONS
<b>Wiring to windlass unsupported other than the wire terminals.</b>	<i>Support wires in accordance with ABYC Standards E-11.</i>

**Windlass - Unsupported Wiring in Anchor Locker**

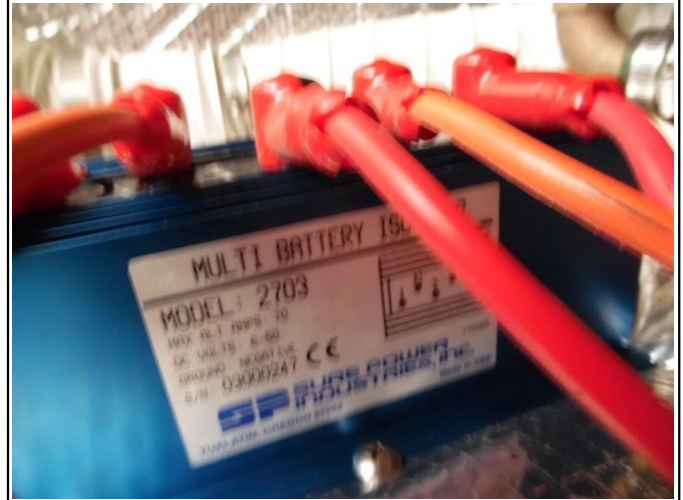
The system has a Sure Power Battery Isolator (Model 2703) that isolates each battery circuit and allows each battery to discharge and charge according to its own needs. As mentioned there are two types of batteries.	
FINDINGS	RECOMMENDATIONS
Two different types of batteries, 6v and 12v.	Verify with manufacturer of Sure Power that this model is designed to handle this situation or replace batteries with like kind.

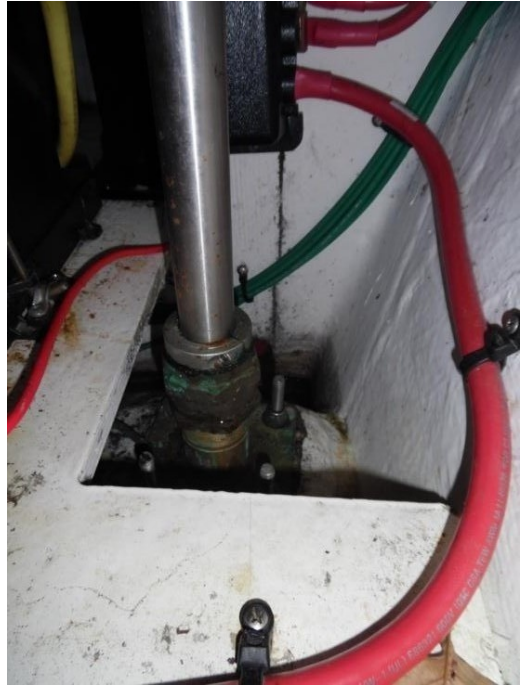
Starboard packing gland leaking.

Bronze hex nut type packing gland. Appeared serviceable. Monitor frequently.	
FINDINGS	RECOMMENDATIONS
Starboard packing gland leaking.	Further investigate and repair as necessary.

**Starboard Rudder Packing Gland**

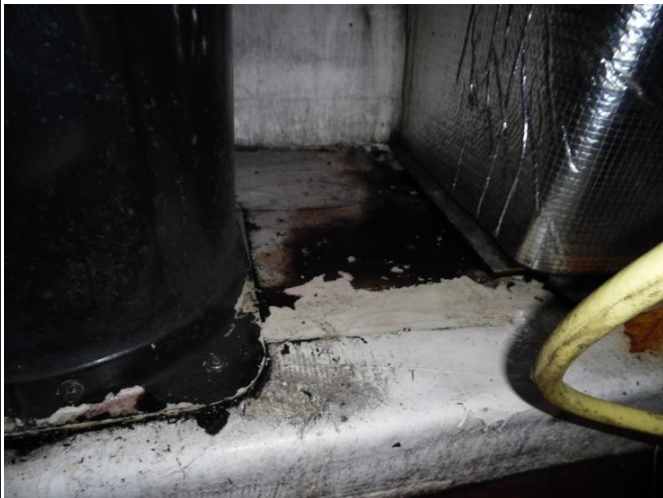
None Sighted. Engine fluid and loose debris falls into bilge area.

**Residual Fluid in Engine Bilge - Port Side**

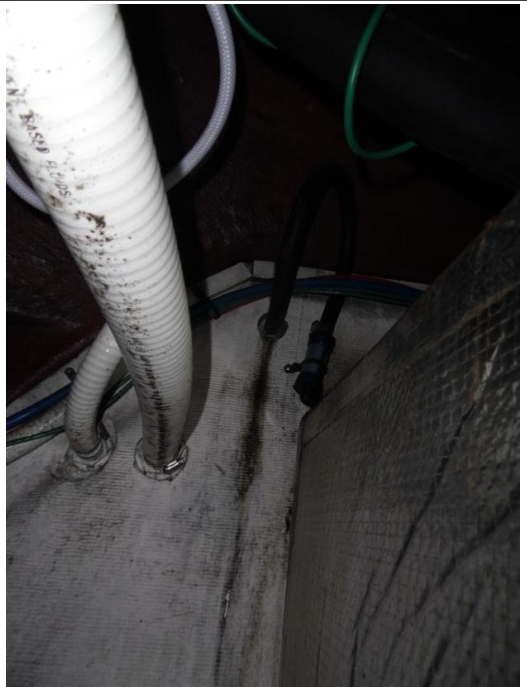
Note: The port gas tank thru-hull vent shows signs of water intrusion into the engine compartment bilge. This could be signs of thru-hull UV degradation.

All the thru-hulls above water were of molded-plastic. Note: The port gas tank thru-hull vent shows signs of water intrusion into the engine compartment bilge. This could be signs of thru-hull UV degradation.	
FINDINGS	RECOMMENDATIONS
Gas tank thru-hull vent shows signs of water intrusion.	Replace with new.

**Indications of Water Intrusion - Port Fuel Vent Thru-Hull**

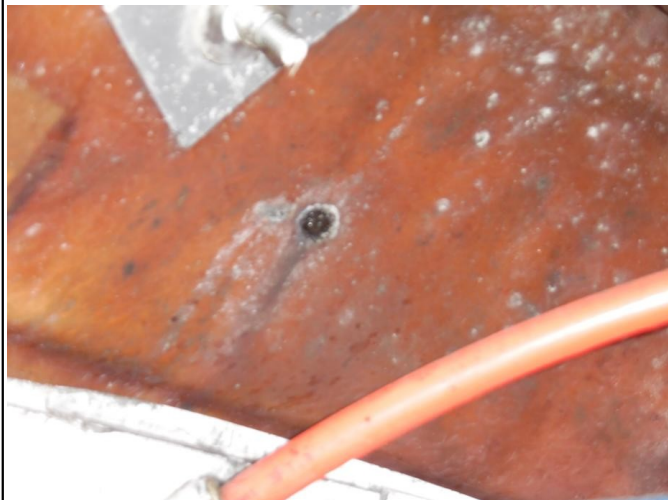
Bolt showing corrosion on swim platform cowling.

Reinforced, FRP fitted with transom door to swim platform. Appears serviceable.	
FINDINGS	RECOMMENDATIONS
Bolt showing corrosion on swim platform cowling.	Investigate further and repair or renew as necessary.

**Swim Platform Bolt - Signs of Corrosion**
