WALKER MARINE SERVICES

Report of Marine Survey

1998 J 120

May 22, 2015

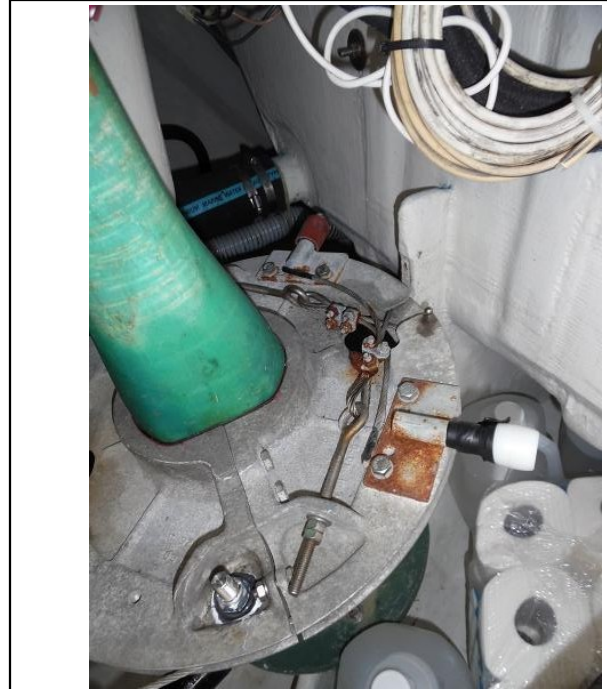
Cable dry with no lubrication and slightly loose. Steering diaphragm and bolts showing signs of corrosion

Steering Adjustments

Appeared serviceable where sighted.	
FINDINGS	RECOMMENDATIONS
Cable dry with no lubrication and slightly loose. Steering diaphragm and bolts showing signs of corrosion	Tighten and lubricate cable and connections. Apply protective coating to corrosion areas.

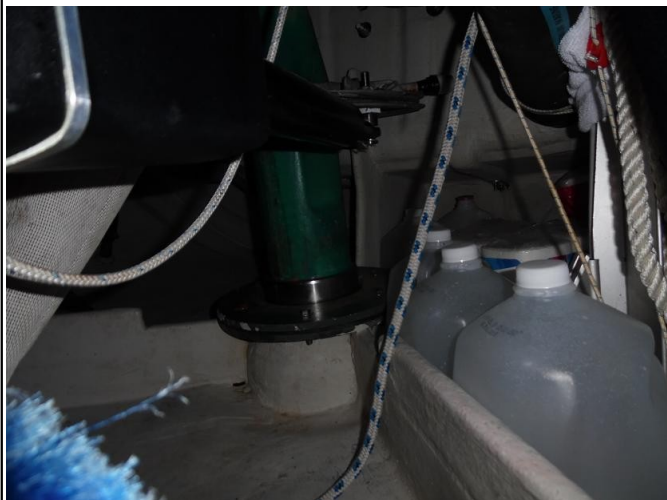
Lower packing gland has evidence of previous water intrusion. Owner reportedly replaced both upper and lower seals. Monitor.

Rudder Lower Seal, Minor Water Intrusion Signs

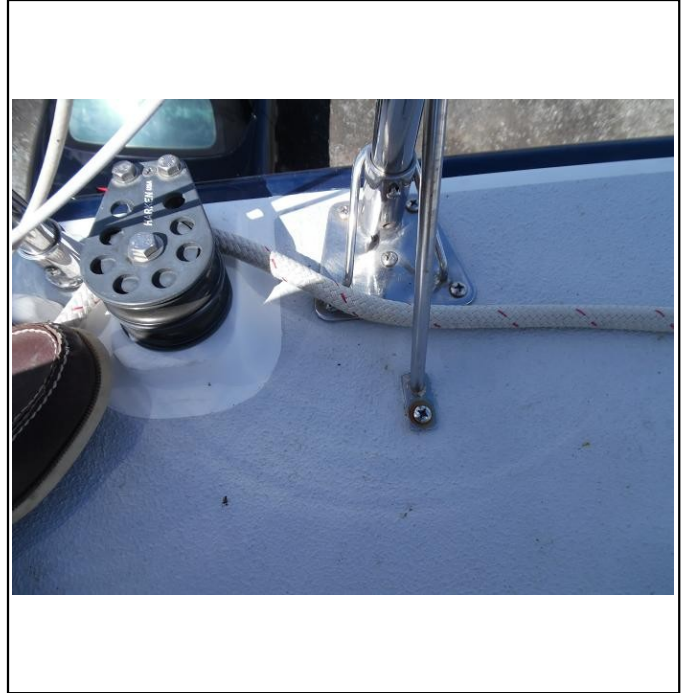
Both fore and aft boarding gate stanchions on both port and starboard decks, show high moisture from percussion soundings and moisture meter readings. Port forward gate stanchion has water intrusion and corrosion signs below in galley cabinet.

Gate Stanchion

Stainless steel stanchions and cable lifelines, run the perimeter of deck from pushpit to pulpit with boarding gates located on both port to starboard sides.	
FINDINGS	RECOMMENDATIONS
Both fore and aft boarding gate stanchions on both port and starboard decks, show high moisture from percussion soundings and moisture meter readings. Port forward gate stanchion has water intrusion and corrosion signs below in galley cabinet.	<i>Repair as necessary.</i>

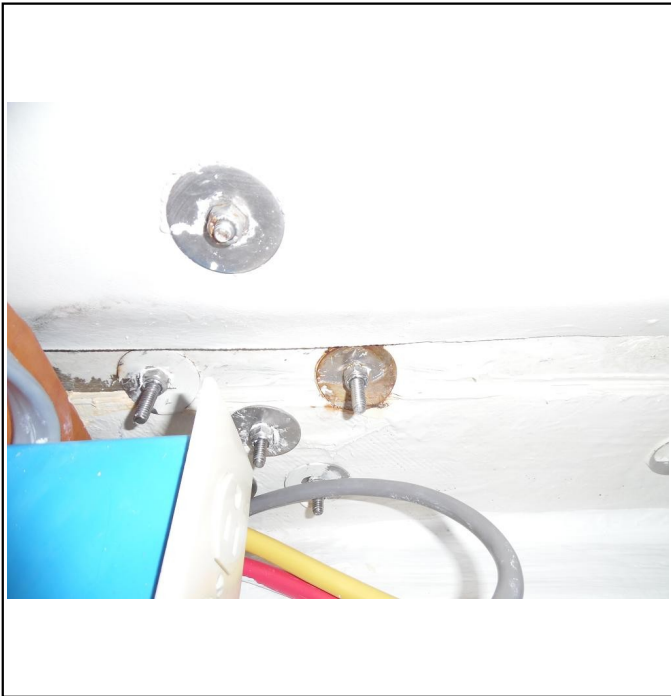
Water Intrusion Signs Port Gate Stanchion

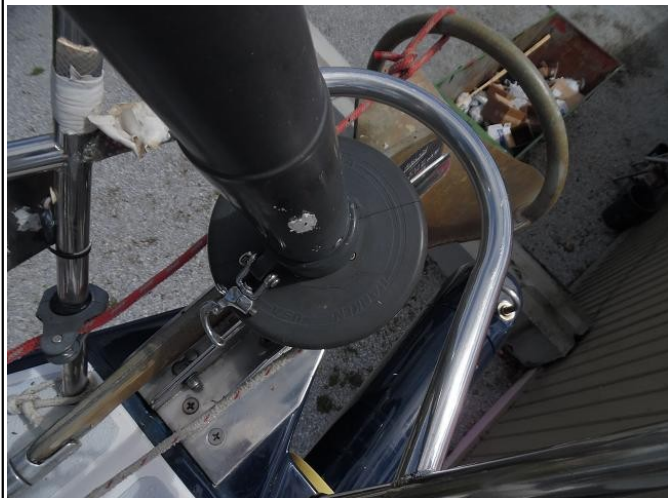
Crack in furling gear housing.

Furler

Harken Furler. Note: Recommend maintenance/lubrication per manufacture's specifications.	
FINDINGS	RECOMMENDATIONS
Crack in furling gear housing.	Investigate unit further, and repair or renew as necessary.

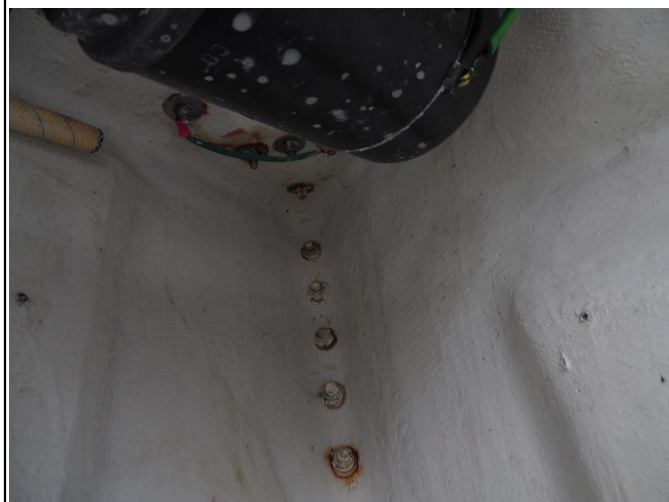
Deck has high moisture around chain plates. Signs of corrosion leaking into anchor locker around chain plate bolts.

Forward Chain Plate In Anchor Locker

Internal chain plates bolted to bulkheads. High moisture indications in deck from percussion soundings and moisture meter. Starboard chain plain has water intrusion signs in discolored trim and water streaks down chain plates. Forestay has water intrusion and corrosion signs inside chain locker.	
FINDINGS	RECOMMENDATIONS
Deck has high moisture around chain plates. Signs of corrosion leaking into anchor locker around chain plate bolts.	Investigate further and repair or renew as necessary.

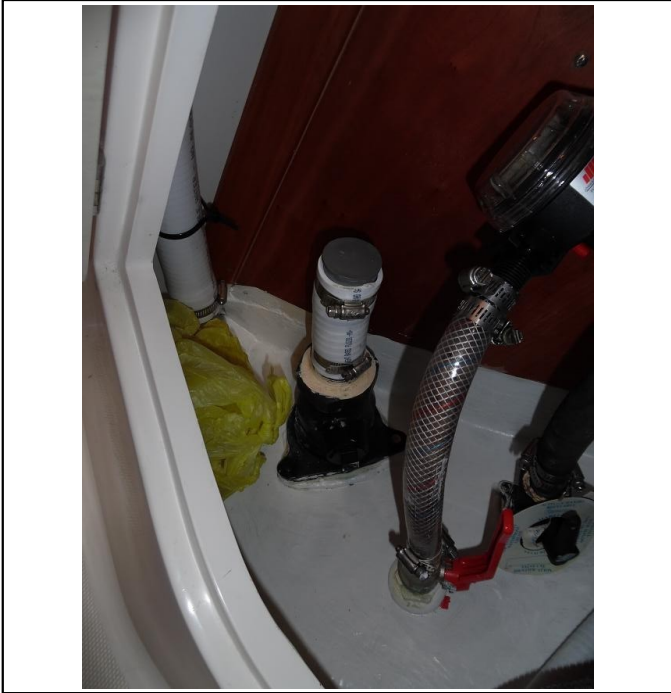
Overboard discharge thru-hull missing handle.

Waste Overboard Discharge

Overboard discharge hose has been cut and capped due to inland EPA discharge regulations.	
FINDINGS	RECOMMENDATIONS
Overboard discharge thru-hull missing handle.	Secure handle in thru-hull location.

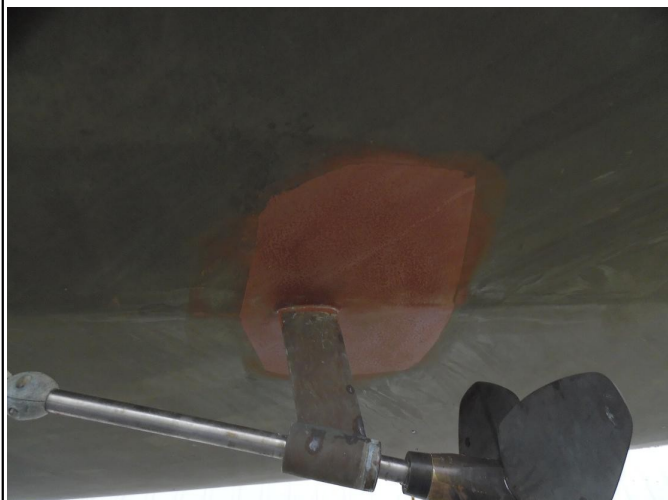
Single I-beam strut. Evidence of repairs and confirmed with seller. Wrapped line around prop/strut and had cracks all around strut plate. Seller removed material and filled area. Reinforced area inside vessel with an extra layer or roving.

Evidence of repairs to hull around strut. Seller do-it-yourself repairs. Unsure of extent of damage or quality of repairs.

Shaft Strut Repair

Single I-beam strut. Evidence of repairs and confirmed with seller. Wrapped line around prop/strut and had cracks all around strut plate. Seller removed material and filled area. Reinforced area inside vessel with an extra layer or roving.	
FINDINGS	RECOMMENDATIONS
Evidence of repairs to hull around strut. Seller do-it-yourself repairs. Unsure of extent of damage or quality of repairs.	Monitor area.

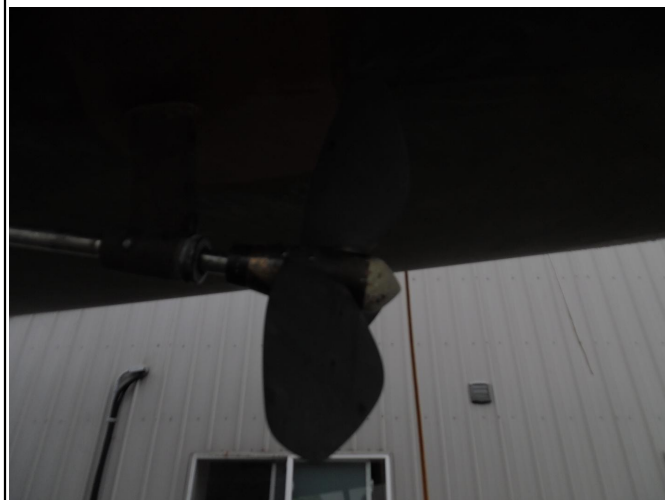
Feathering Prop with Anode

Propeller protected by dedicated anode.	
FINDINGS	RECOMMENDATIONS
Dedicated anode appears to be for fresh water.	Replace anode with zinc for salt water.

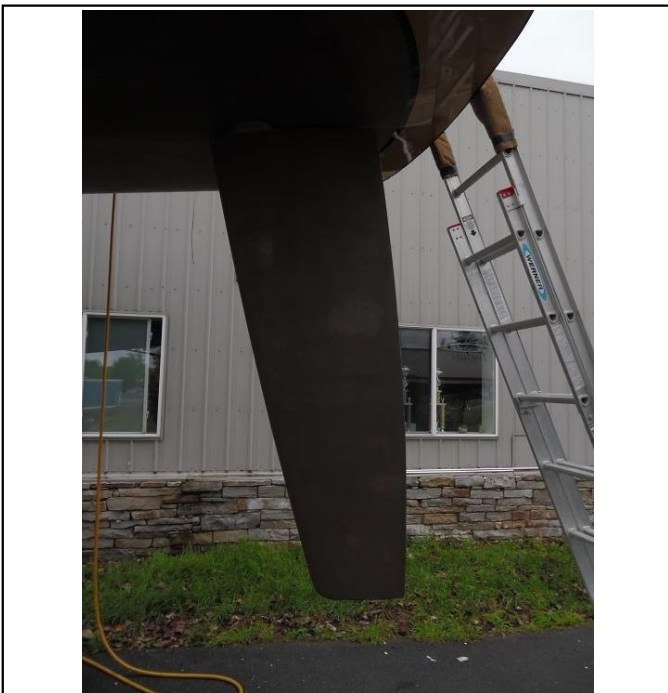
Bottom portion of rudder has higher moisture readings than other areas.

Rudder

FRP (fiber reinforced plastic) with internal support.	
FINDINGS	RECOMMENDATIONS
Bottom portion of rudder has higher moisture readings than other areas.	<i>Monitor and repair as necessary.</i>

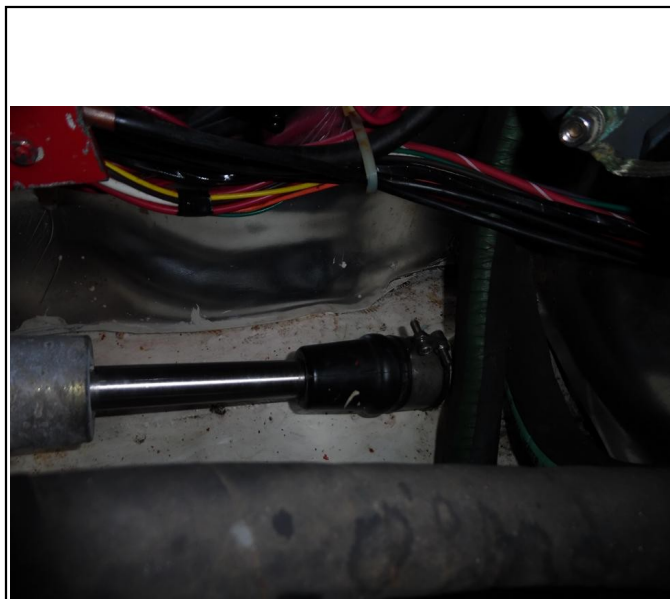
Stuffing box appeared serviceable. Monitor frequently for leakage.

Stuffing Box
