WALKER MARINE SERVICES

Report of Marine Survey

1998 J 120

May 22, 2015

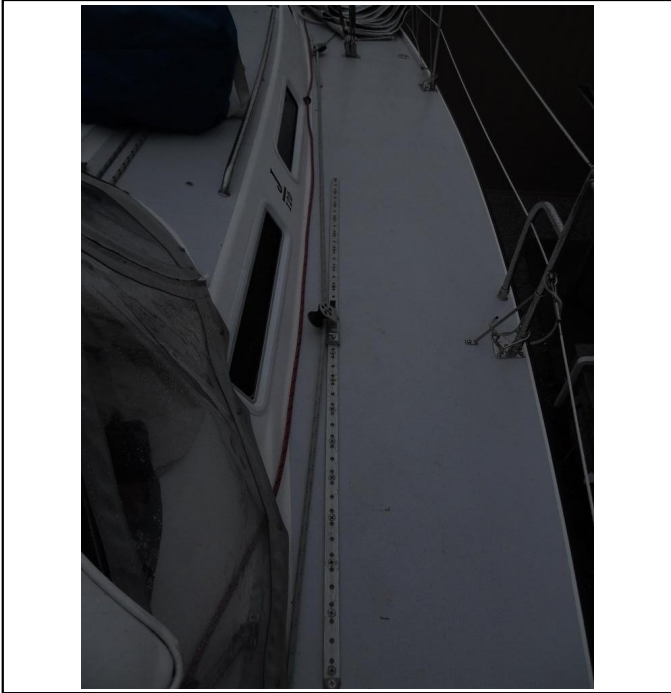
Port Side Deck

Deck surface is gray non-skid with white outline. Entire deck surface applied when deck was repaired by seller. In various areas the deck coating is peeling, not chipping, showing signs indicative of poor adhesion.

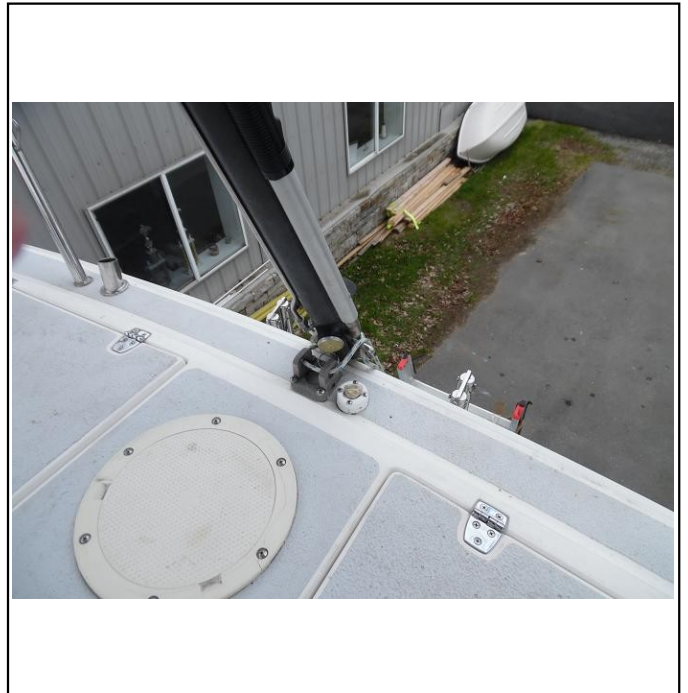
The second group of areas are fore and aft gate stanchions, on both port and starboard sides. A smaller area was found forward of the back stay around the plate.

**Emergency Tiller Access/Rear Plate
Forward of Backstay**

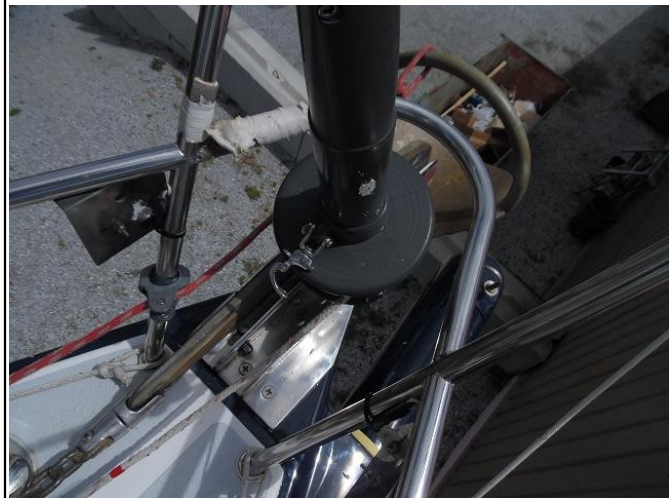
Bowsprit is stainless steel with integrated anchor roller.
